**Subject: Property Maintenance Inspection of Hen Island**

## International Property Maintenance Code (IPMC) Inspection Checklist

**Hen Island  
Rye, New York**

**Inspection Date:** July 18, 2018

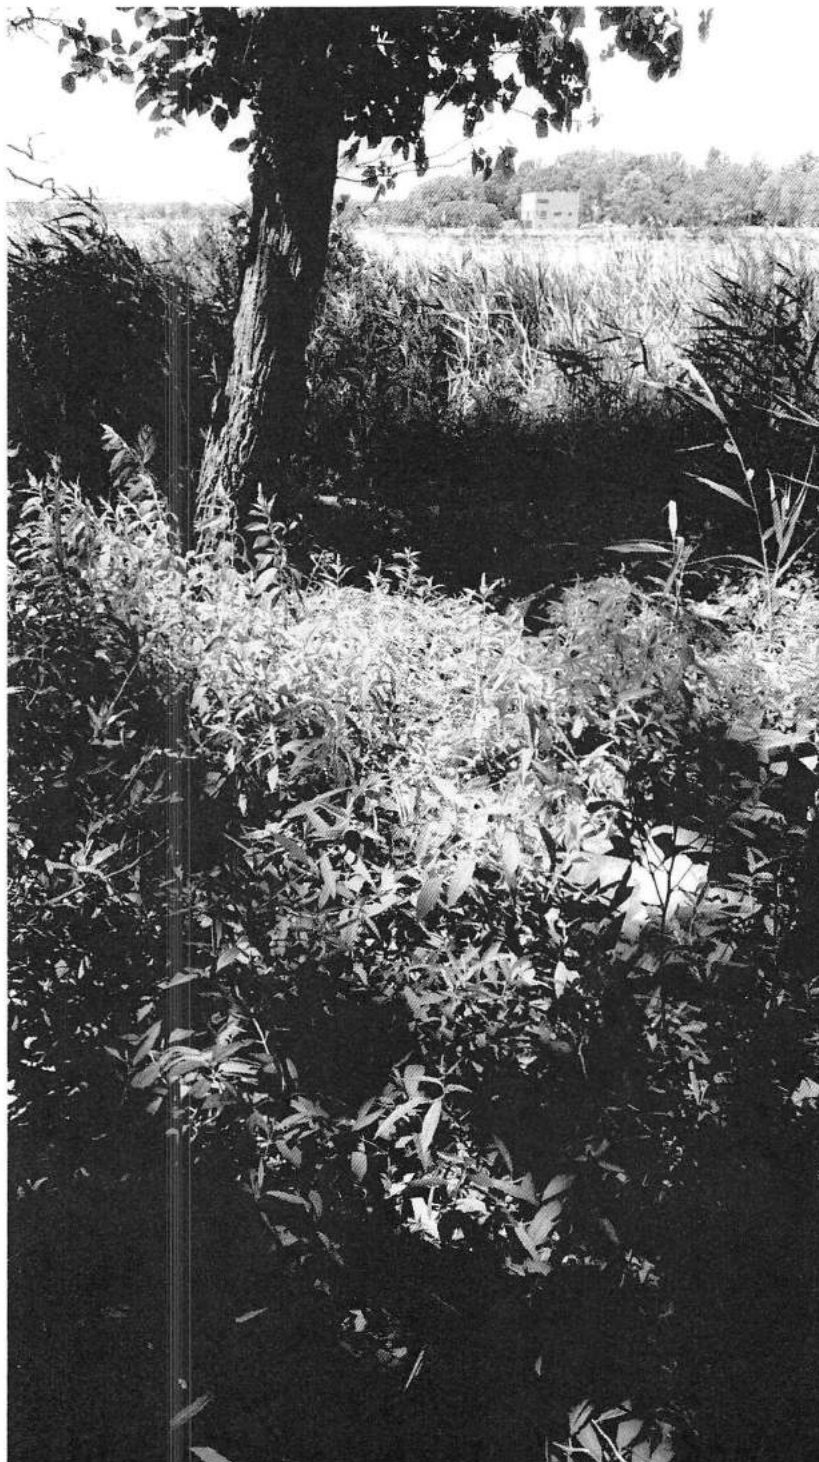
Yes	No	Condition/Type	Action	Quantity
<b>302.1 Sanitation</b> Clean and free from rubbish and garbage	X		Primarily complaint.  However, construction debris was found in a grassed area on edge of property on North Island.  Some unknown construction debris was found below brush on the South Island.	Remove rubbish and dispose of offsite.	2
<b>302.2 Grading and Drainage</b> Erosion of soil, ponding/stagnant water, water within structure		X			
<b>302.3 Sidewalks and Driveways</b> Proper repair, free from hazards (tripping, ice ponding)	X				
<b>302.4 Weeds</b> Noxious weeds, growth height		X			
<b>302.5 Rodents</b> Evidence of presence? Harborage? <input type="checkbox"/> Weeds <input type="checkbox"/> Rubbish <input type="checkbox"/> Garbage Inoperable cars		X			
<b>302.6 Exhaust vents</b> Hazardous discharge/noise		X			
<b>302.7 Accessory structures</b> Structurally sound/ good repair Structure type <input type="checkbox"/> Garage <input type="checkbox"/> Fence <input type="checkbox"/> Wall Other _____	X		Primarily compliant.  However, an accessory structure located on South Island had sustained extensive damage in a recent storm. The structure was unsafe and should be demolished.	Post structure as unsafe, demolish.  *It was noted work was being performed by the owner to demolish and remove the unsafe structure.	1

Construction debris in brush.

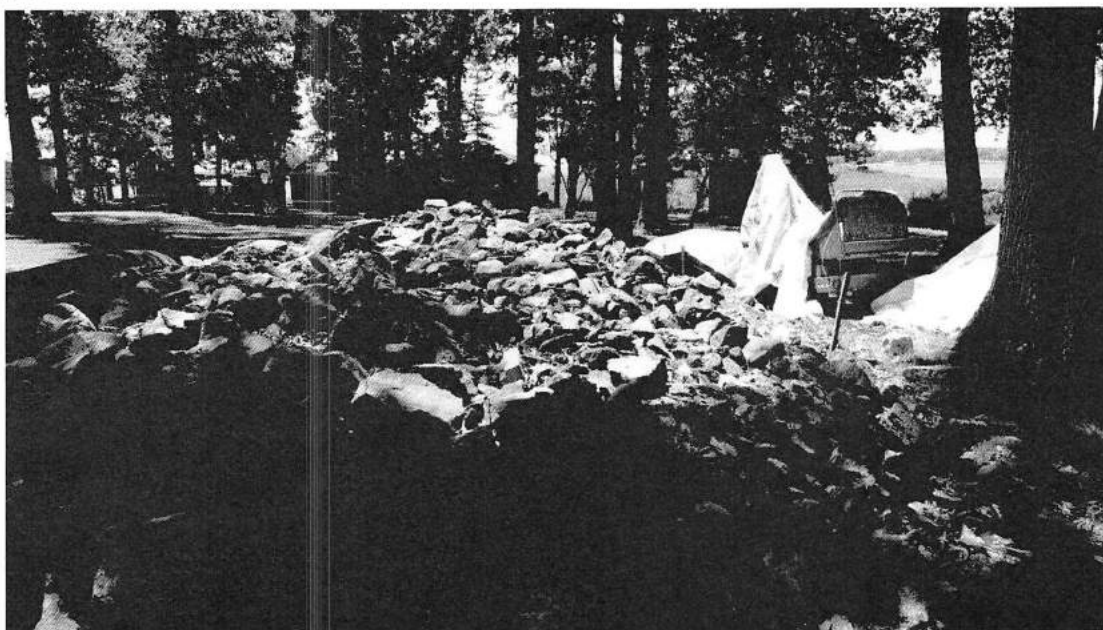
Construction material staging in center of island.

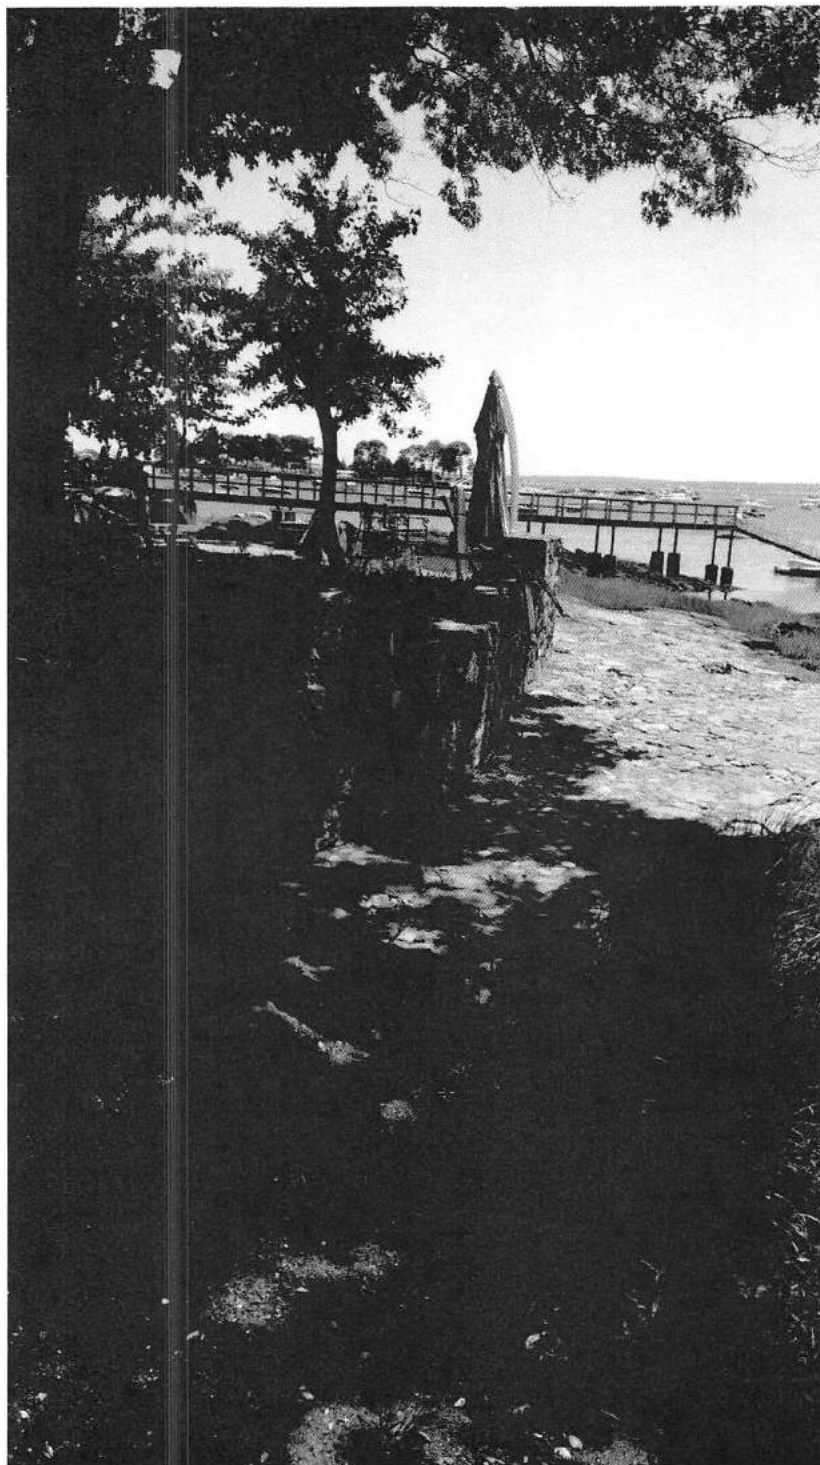
Typical stone wall and walkway.

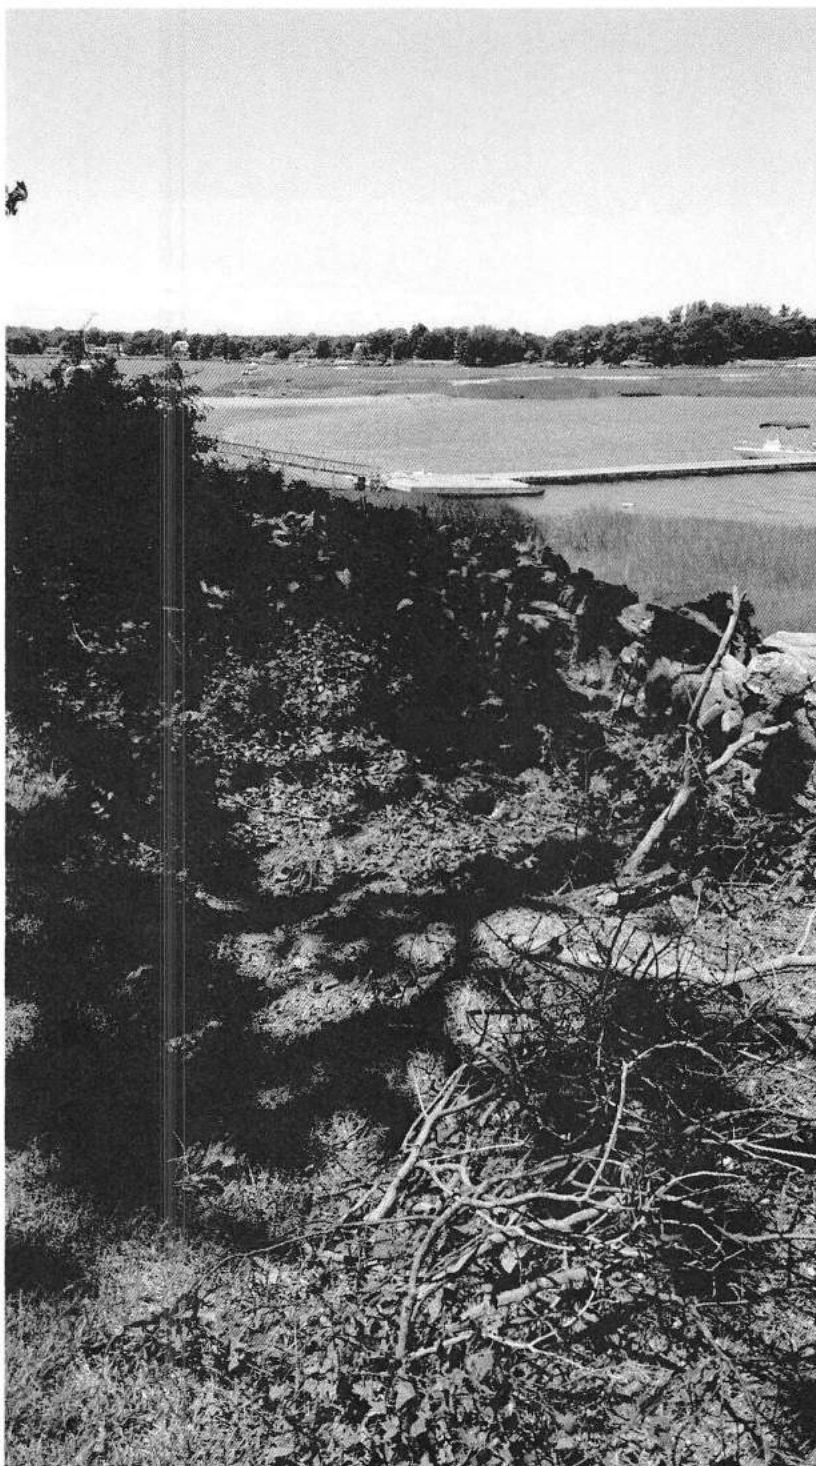
Brush and leaf pile. Some construction debris was notes in brush.

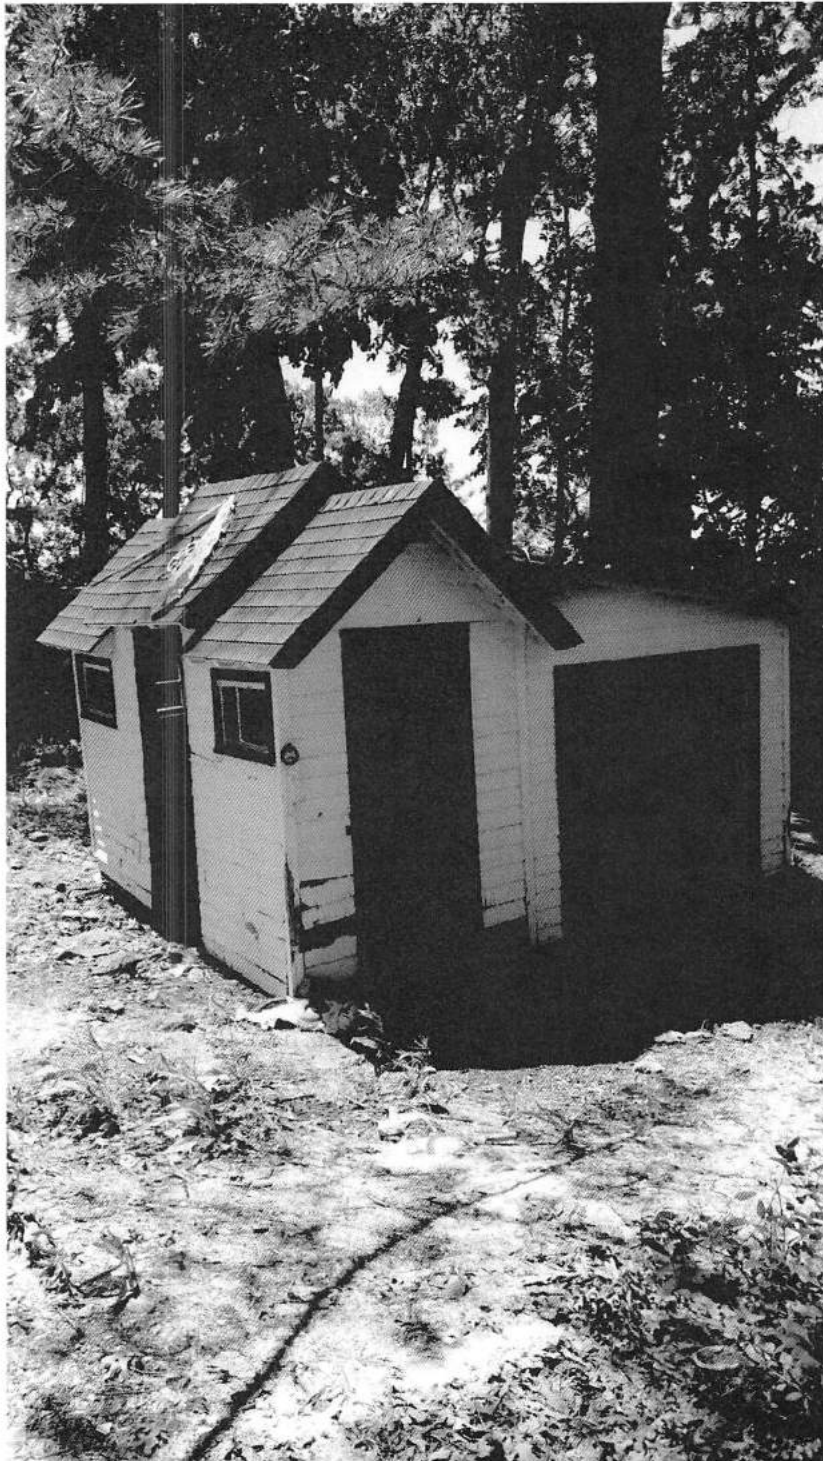
Damaged, unsafe accessory structure.

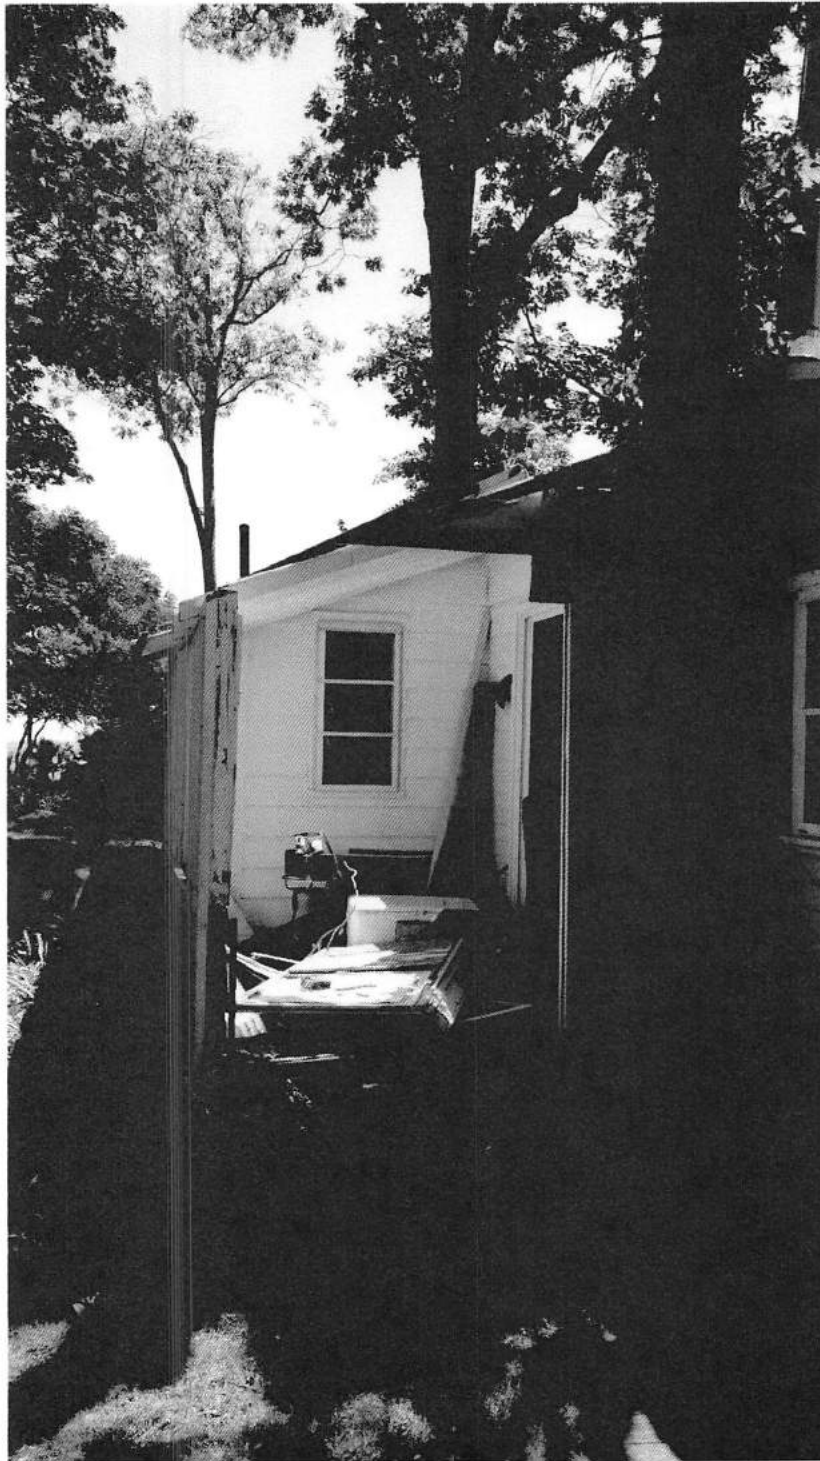
Yes	No	Condition	Action	Quantity
<b>304.1 General</b> Good repair, structurally sound, sanitary	X		One structure on the South Island had suffered damage during winter storm to entrance.	Damaged materials should be removed and re-build.	1
<b>304.2 Protective treatment (Paint)</b> Is it pre 1978? If yes, order risk assessment			Unknown		
<b>304.3 Premises identification</b> (address numbers)	X				
<b>304.4 Structural members</b> Free from deterioration and capable of support	X				
<b>304.5 Foundation walls</b> Plumb, free from cracks, no rodent entry	X				
<b>304.6 Exterior walls</b> Sound, weatherproof, coated Square feet _____	X				
<b>304.7 Roofs and Flashing</b>	X				
<b>304.7 Roof drainage</b> Gutters, downspouts, drains	X		Limited gutter and downspout work needed, typically associated with rainwater collection system. Overall was in good condition on structures observed.		
<b>304.8 Decorative features</b> <b>304.9 Overhand extensions</b> Good repair, safe, anchored, coated	X

Storm damage to entryway of main structure.

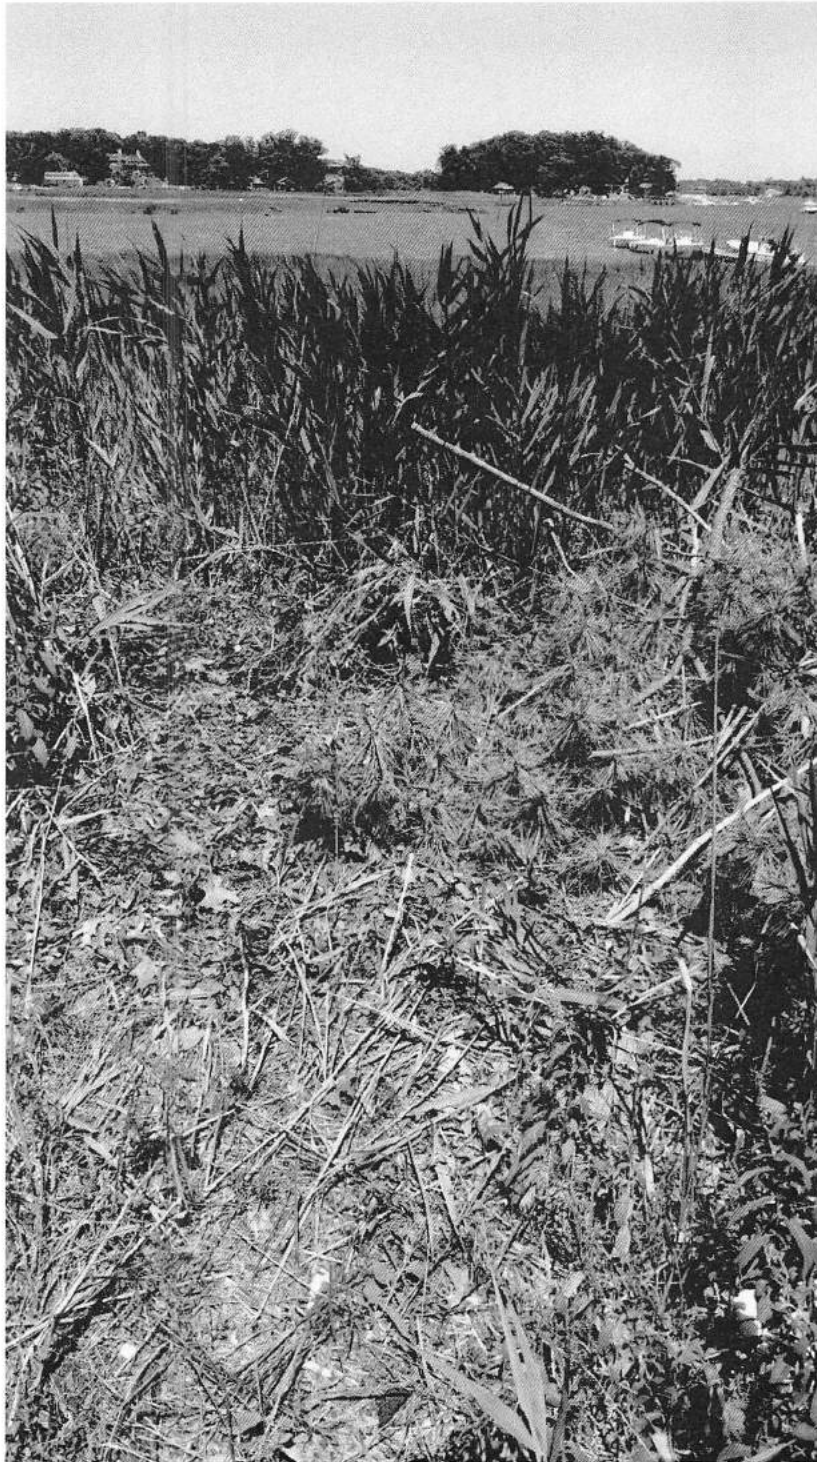
Condition	Corrective Action
There were multiple locations where branches, leaves and other yard waste had been dumped in an area that appeared to be wetlands. While this is not covered under the property maintenance code, the City of Rye prohibits this activity.	All yard waste should be removed from the property or composted in accordance with City of Rye requirements, §157-26 <i>Preparation of wastes for collection</i> .

Leaves and brush in wetlands.
